**CITY OF PITTSBURGH
 DEPT. OF MOBILITY & INFRASTRUCTURE**

EL PASO STREET LANDSLIDE REMEDIATION
 10TH WARD - CITY OF PITTSBURGH
 ALLEGHENY COUNTY, PENNSYLVANIA
 EXISTING CONDITIONS - SITE PLAN

DRAWN BY: ETB SCALE: AS SHOWN SHEET NO: 3 OF 55 ACCESSION NO: CASE NO:

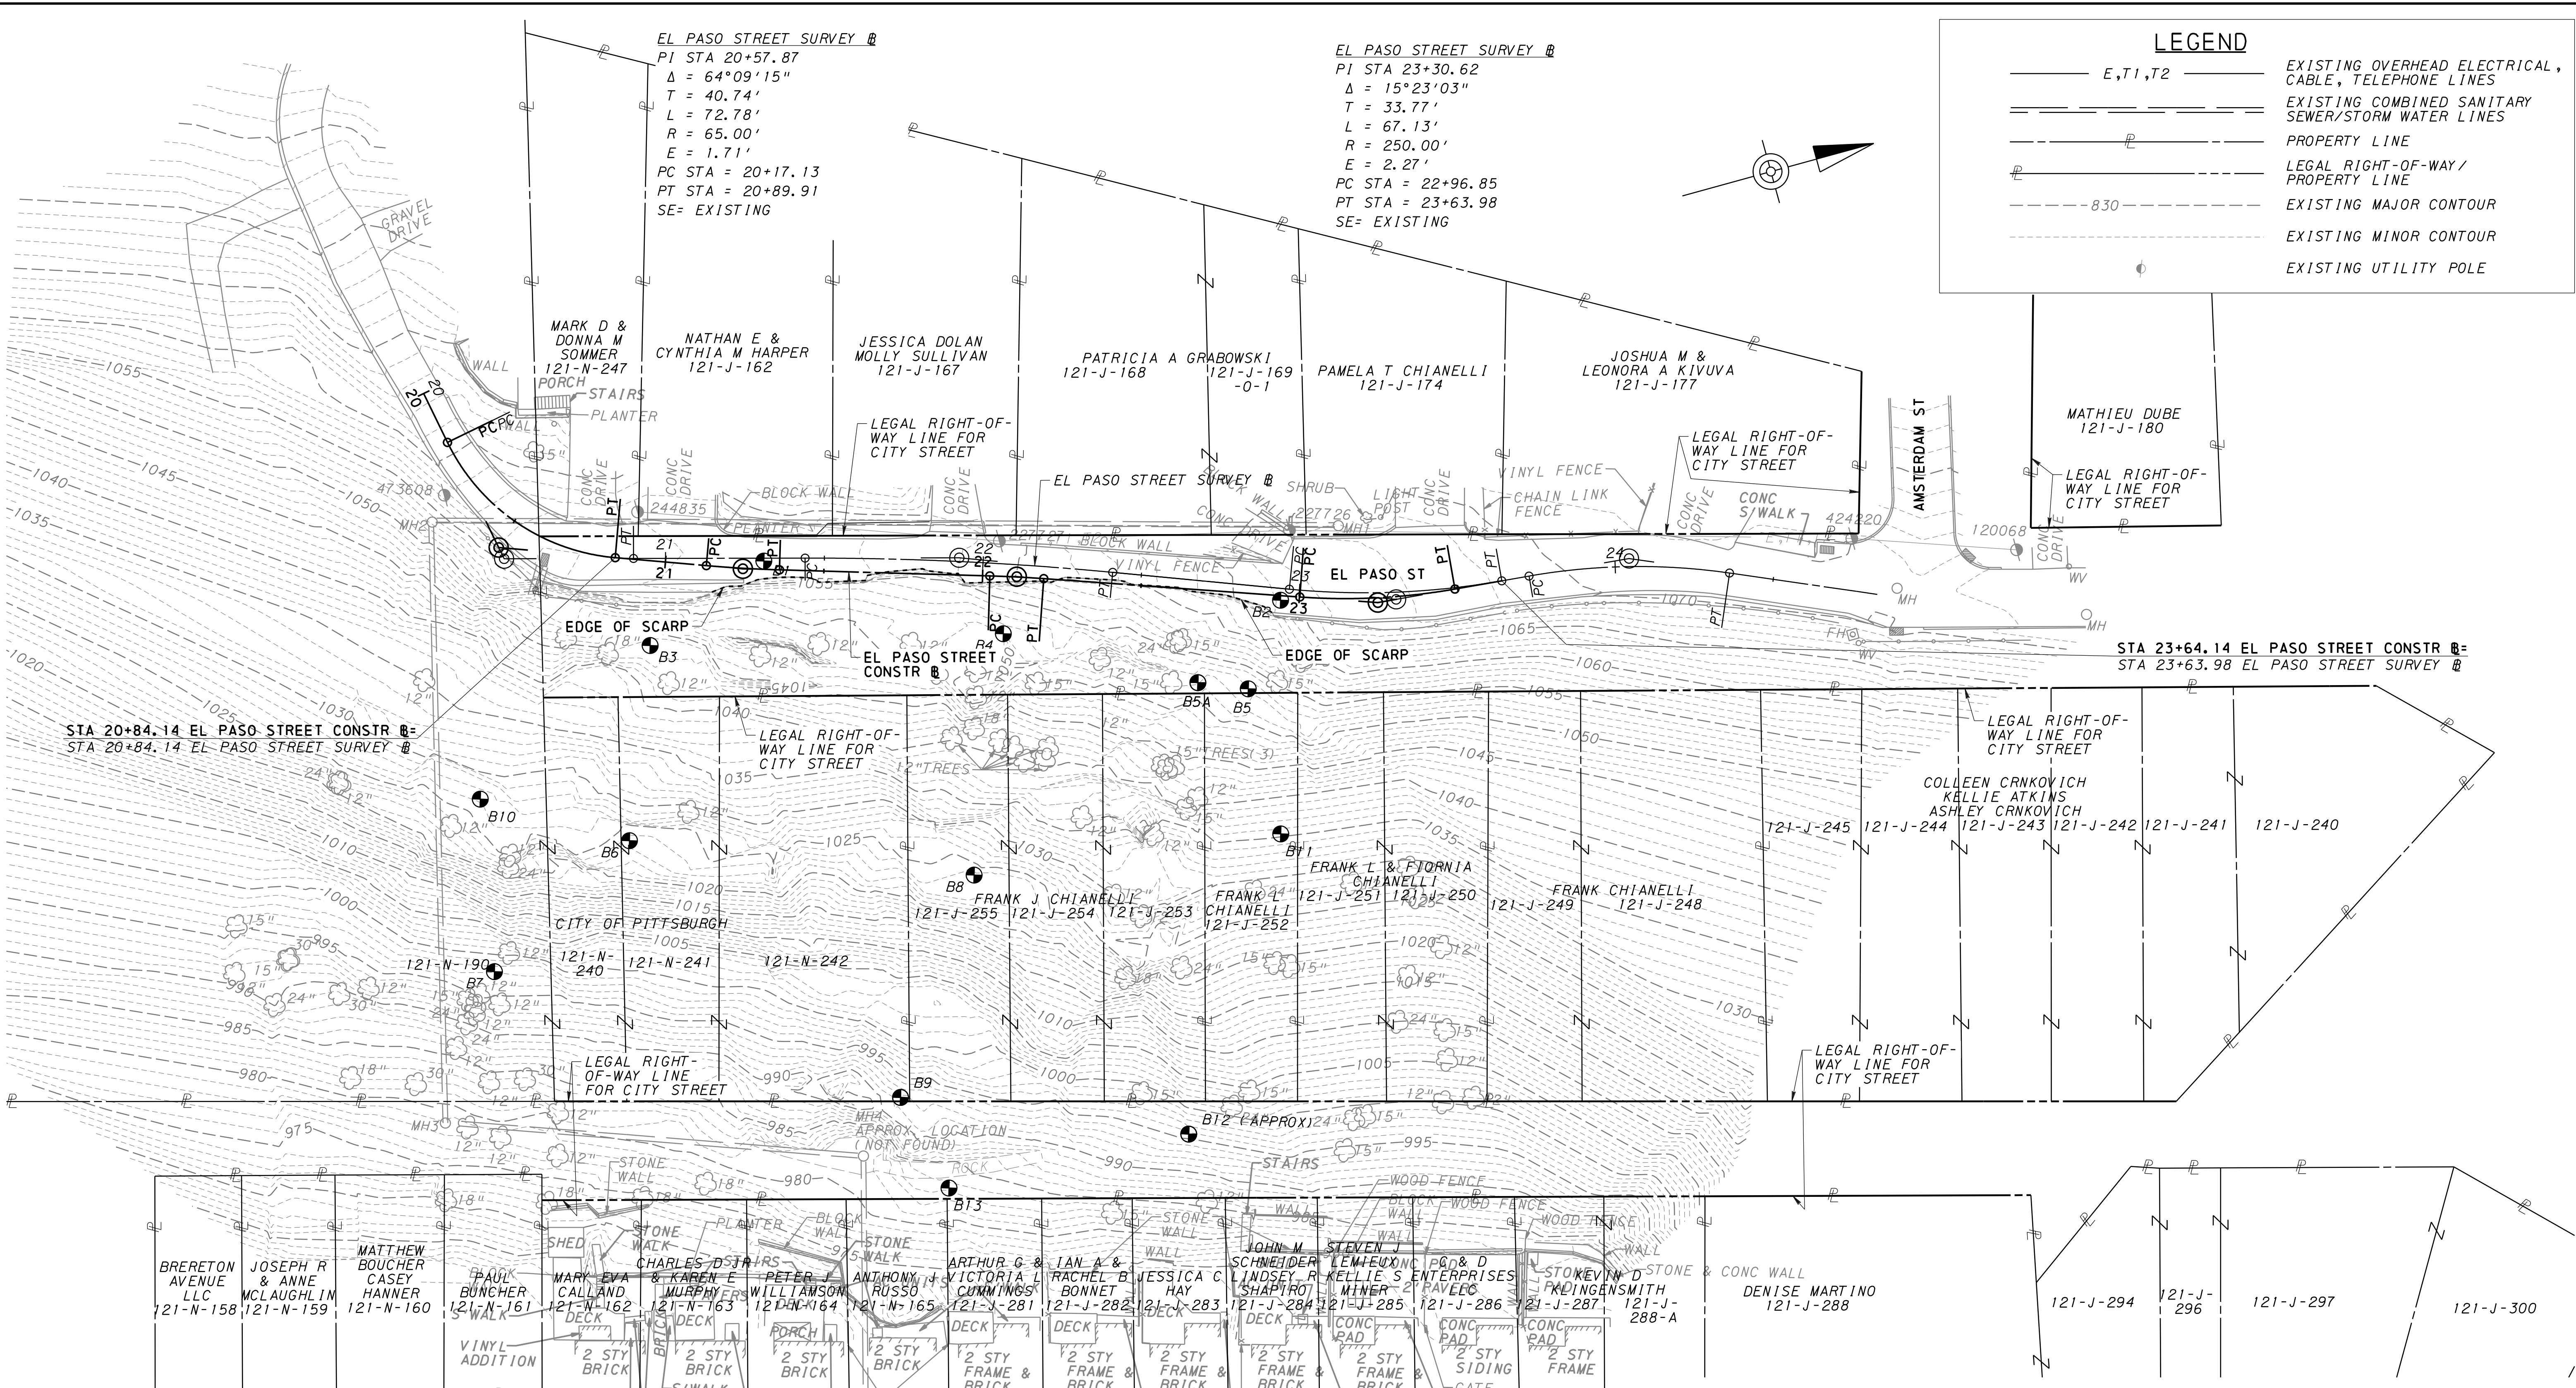
EL PASO STREET SURVEY #
 PI STA 21+92.49
 $\Delta = 5^{\circ}33'29''$
 $T = 48.54'$
 $L = 97.01'$
 $R = 1000.00'$
 $E = 1.18'$
 PC STA = 21+43.94
 PT STA = 22+40.95
 SE= EXISTING
